DYNAMIC AND ENVIRONMENTAL EVALUATION OF
COMPLAINT FOIL GAS LUBRICATED BEARING

Airesearch Manufacturing Company of Arizona

Air Force Aero Propulsion Laboratory

AFAPL-TR-73-56

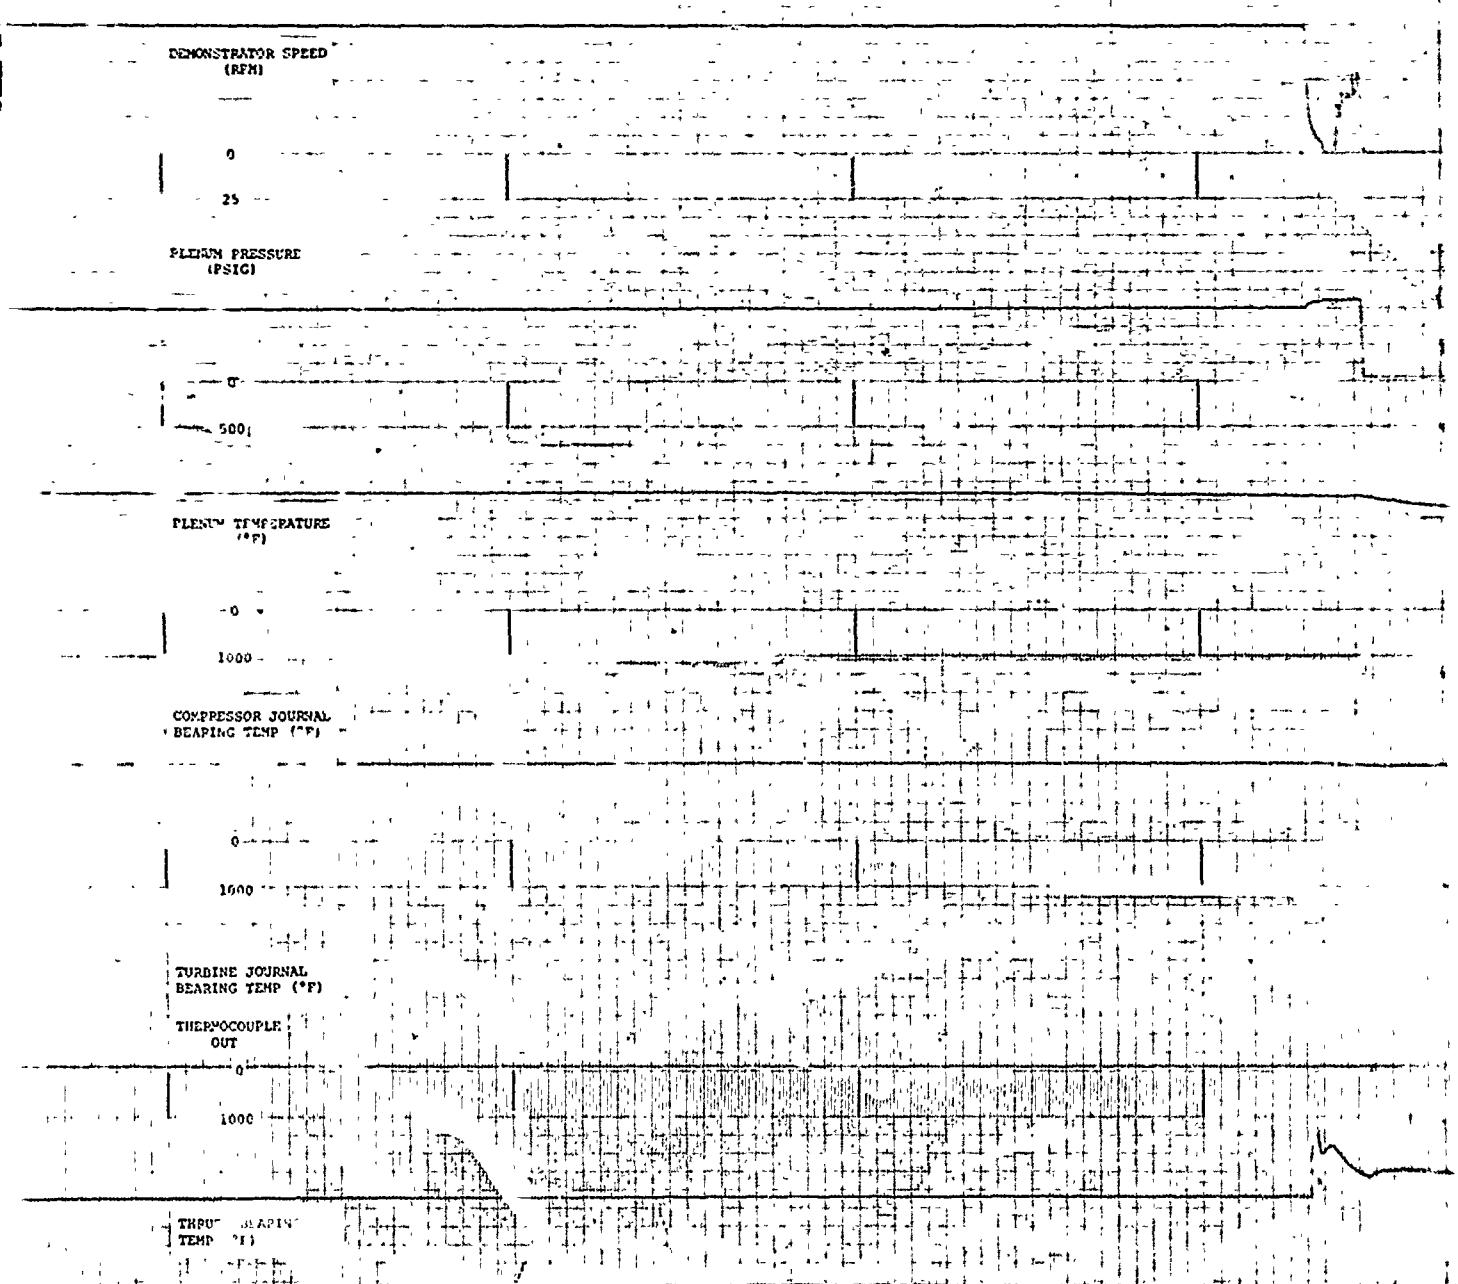
Figure 51. Sandborn trace showing final seconds of overtemperature test.

As can be seen from Table IV, a plenum temperature of 340°F and a plenum pressure of 10 psig were required to maintain unit speed at 70,000 rpm and thrust bearing temperature at 550°F. During approximately the last half minute of operation, the bearing heat generation increased, which increased the temperature of the bearing. In an effort to reduce the temperature to 550°F, the delivery air temperature was reduced. This continual reduction resulted in a slight drop in unit speed and maintained the bearing temperature at 560°F. Other than the increase in bearing temperature, there was no warning prior to bearing seizure. The bearings operated in the 550°F high temperature environment for 600 seconds. Figure 51 shows the Sandborn trace at the end of bearing seizure.
